UNDERWATER TECHNOLOGY FOR POLAR RESEARCH

G.A.RAMADASS

**National Institute of Ocean Technology
(Ministry of Earth Sciences), Chennai**

Specifications of PROVe

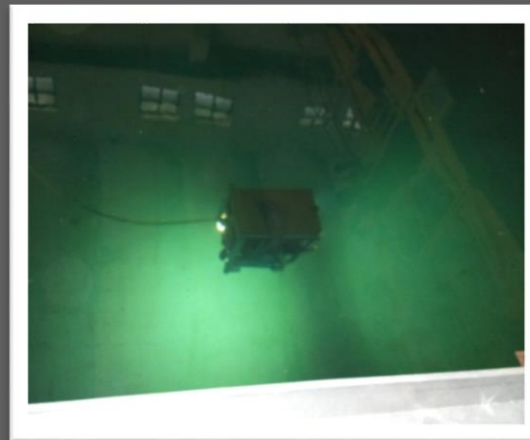
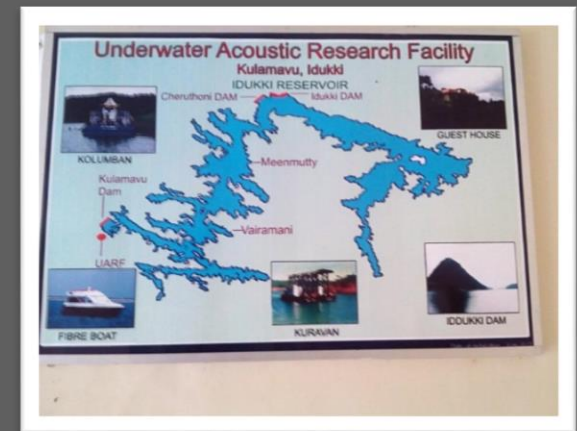
ROV Integration and Testing at ATF

- Integration of vehicle subcomponents
- Integrated dry test was carried out with surface control unit, deck power system, umbilical cable and ROV
- Integrated wet test was carried out at ATF and Idukki Lake
 - Sensors and subcomponents tested
 - Vehicle maneuvered in 4 DOF

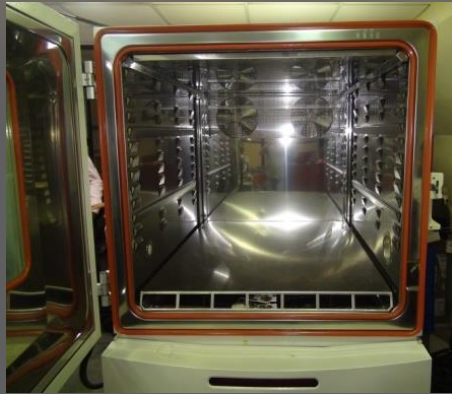
ROV placed in Environmental Chamber

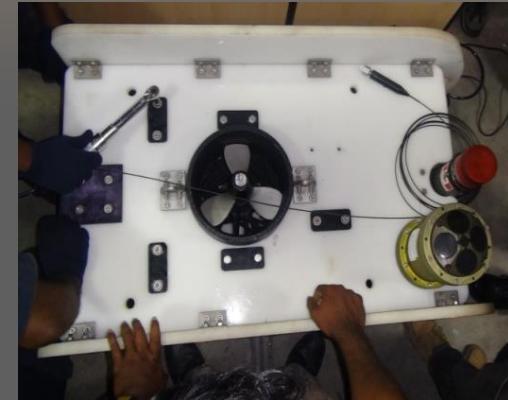
Ready for test with power

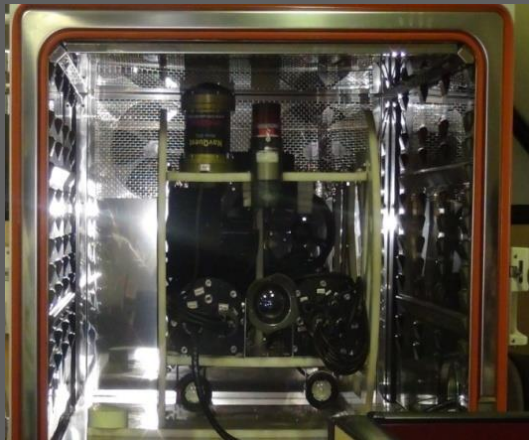
After the test

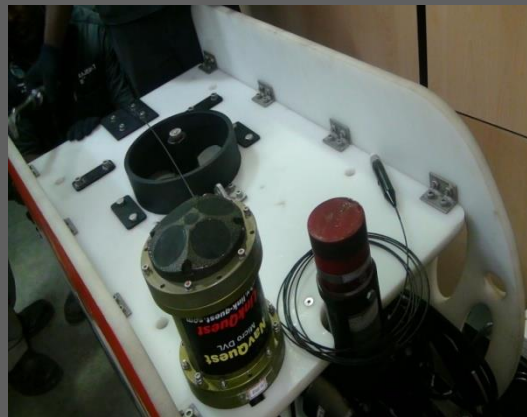
Status of Sensors after test

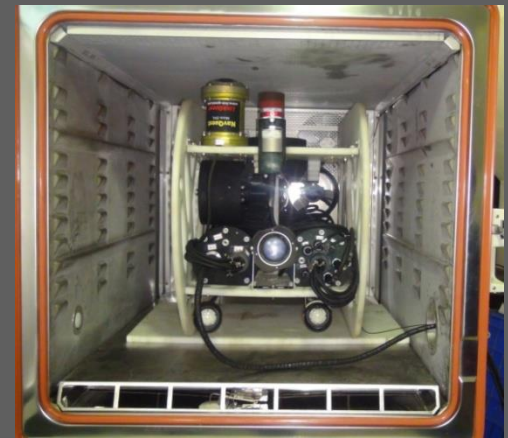
Checking of Torque of fastened bolts

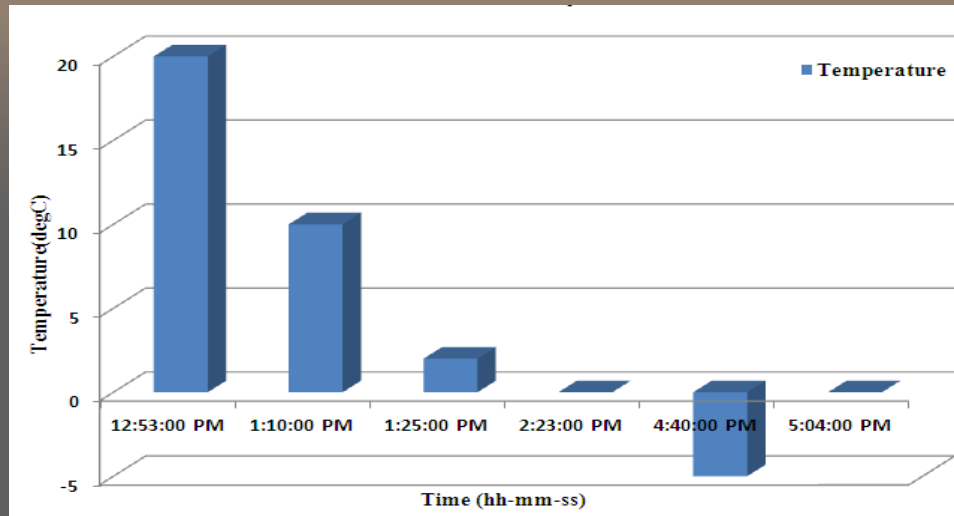
Environmental Chamber Test

Stage	Temp (°C) in Test Chamber	Test Duration			System Status	DTS temp	DVL Temp	Load test
		Start time	End time	Duration(min)		(°C)	(°C)	
1	20	12:53	01:08	15	ON	33.4	28.5	Color Camera,B&Wcamera, LED-4no's,Compass,DVL,S ONAR,SBG,Thruster 4no's cranking Tested in all conditions
2	10	01:10	01:20	10	ON	35.0	24.4	
3	2	01:25	02:20	55	OFF	28.3	5.2	
4	0	02:23	04:30	117	OFF	7.7	0.7	
5	-5	04:34	05:04	30	OFF			
6	0	05:10	05:20	10	ON	4.6	-1.7

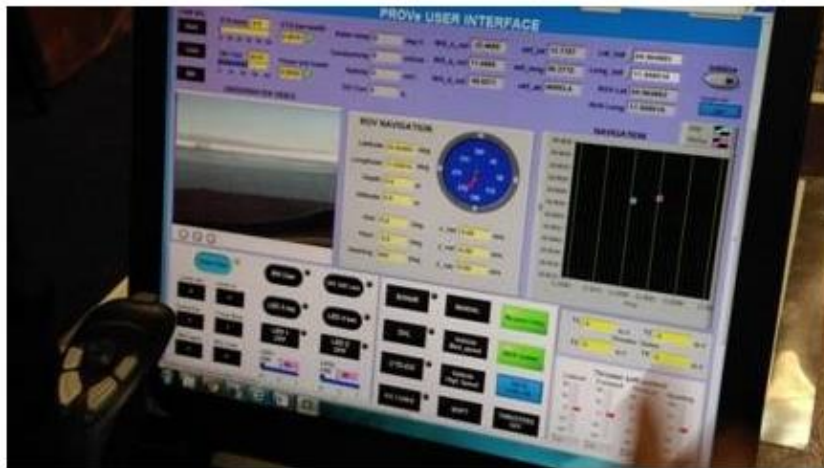
Console screen during dry test

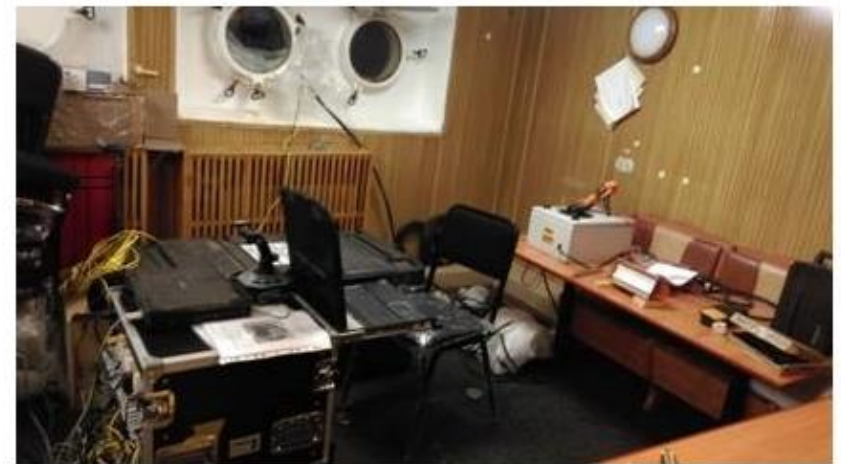
Control console and power system

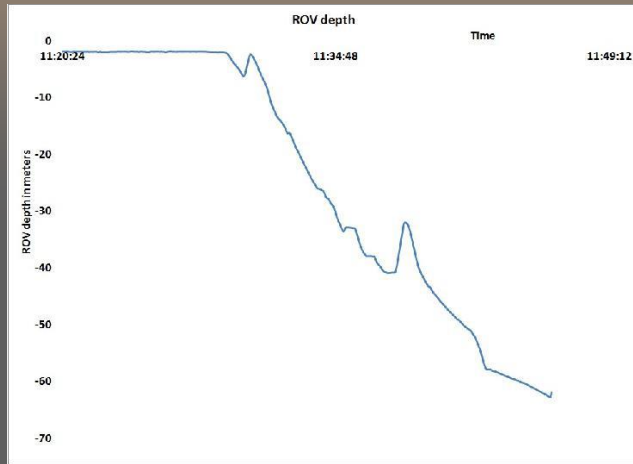
Depth log

Scientific data acquired from on-board sensors

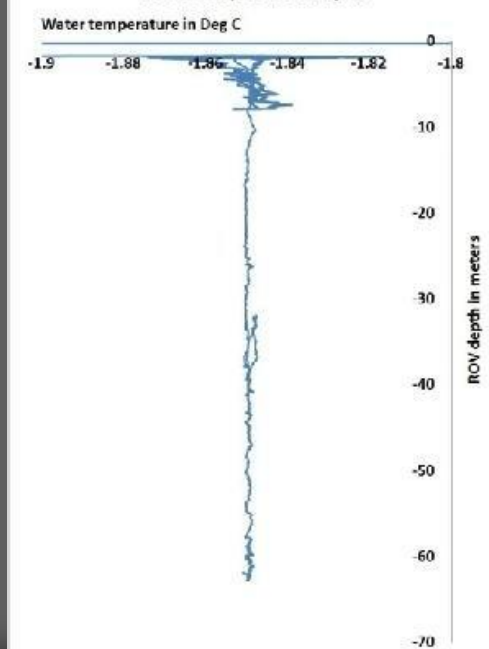
water temp Vs ROV depth

Water
temperature
log
